# INVESTIGATION REPORT OF THE FIRE AT STOUFFER'S INN OF WESTCHESTER

Harrison, New York

JAMES R. BELL

On December 4, 1980, a fire occurred on the third floor of the conference facility at the Stouffer's Inn of Westchester, which was located in Harrison, New York. Of approximately 95 occupants who were attending meetings in several conference rooms, 26 persons lost their lives and 24 were injured. The fire did not involve guest-room facilities of the hotel complex.

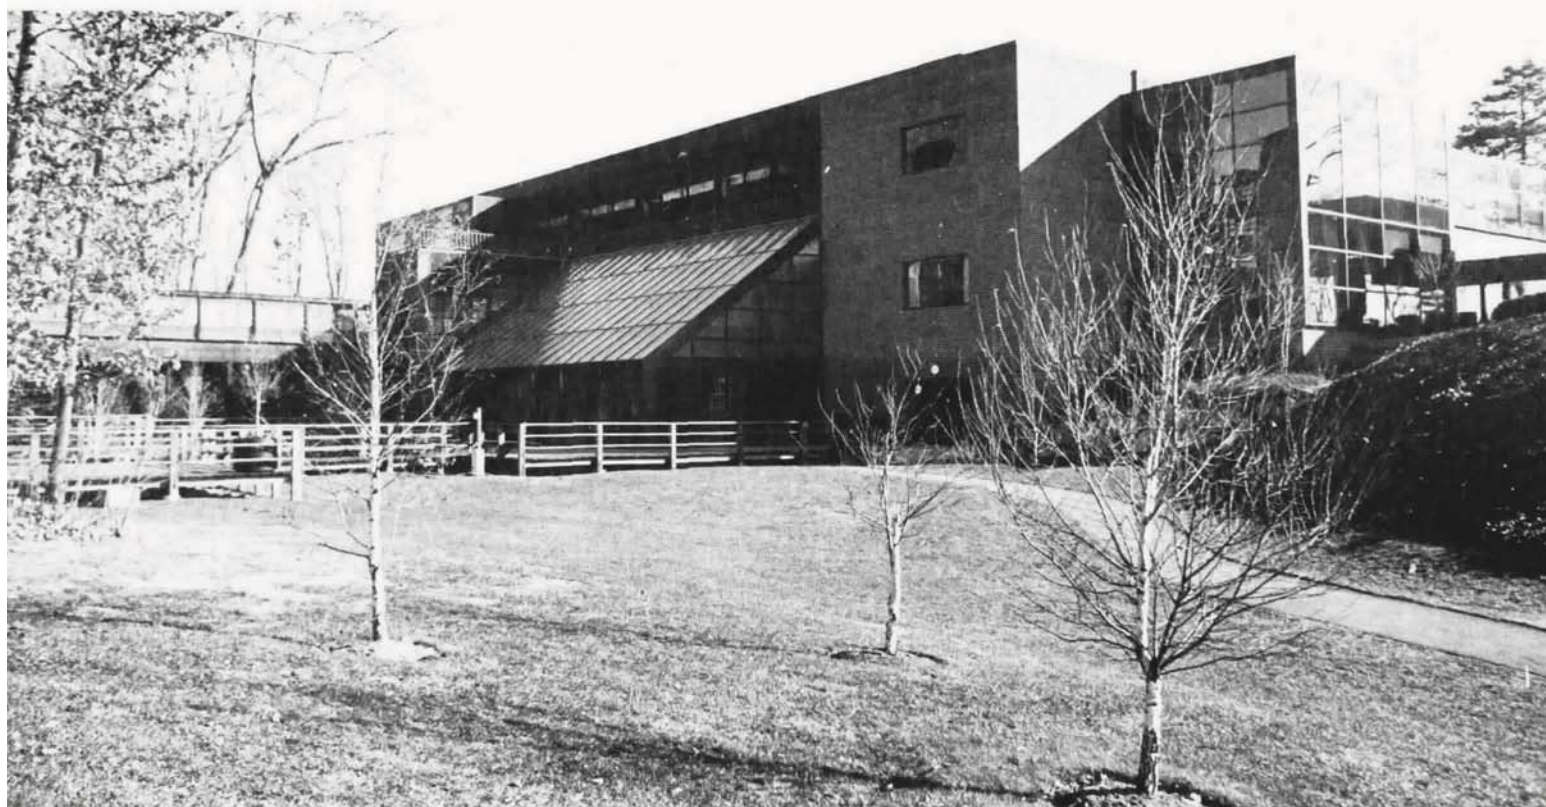
Below: The Conference Center from the southwest. The railings of the promenade deck and windows of the burned-out Common area of the third floor are above the slanted, glassed-in area housing the indoor swimming pool.

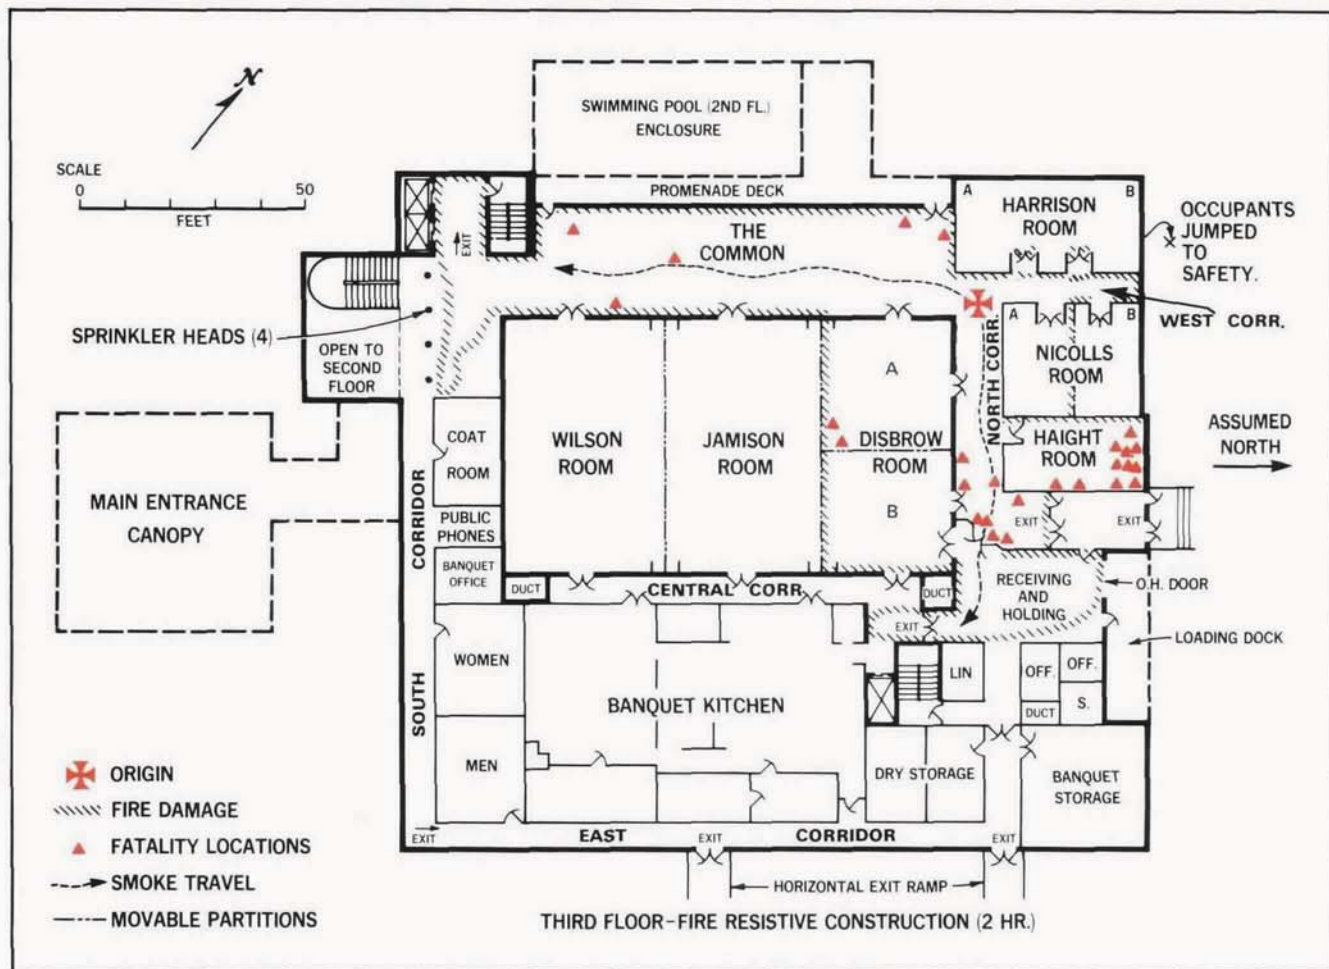
Figure 2. Layout of third floor.

The Common served as the focal point and key exit access corridor for the conference facility on the third floor and also as a lobby for the Grand Ballroom. The Common provided access to the Wilson Room, the Jamison Room, and the Disbrow Rooms, the designations for the meeting rooms that could be created within the Grand Ballroom by movable steel wall partitions. The Disbrow Room on the east end of the Ballroom could be further subdivided into two smaller meeting rooms, Disbrow Rooms A and B, by means of another movable steel wall partition. On the morning of the fire, the movable partitions had been extended to subdivide the Ballroom into four meeting areas, three of which were occupied at the time of the fire. (See Figure 2.)

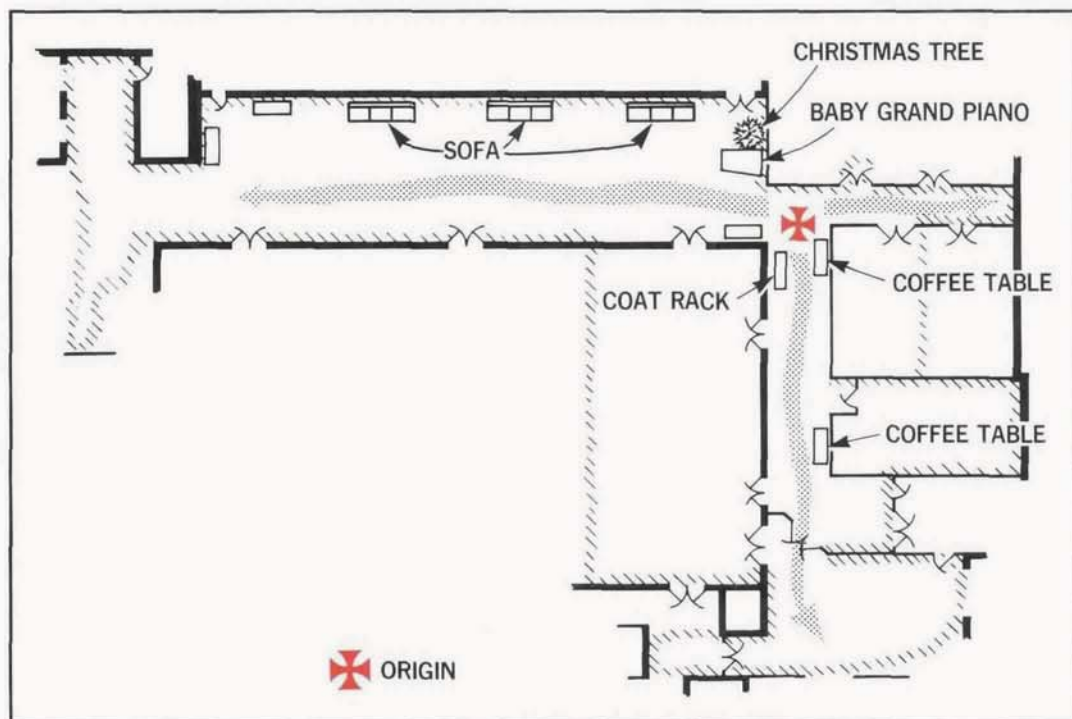
Figure 3. Simplified representation of contents in North Corridor and The Common, plus smoke and flame spread (indicated by dotted pattern). Drawing not to scale.

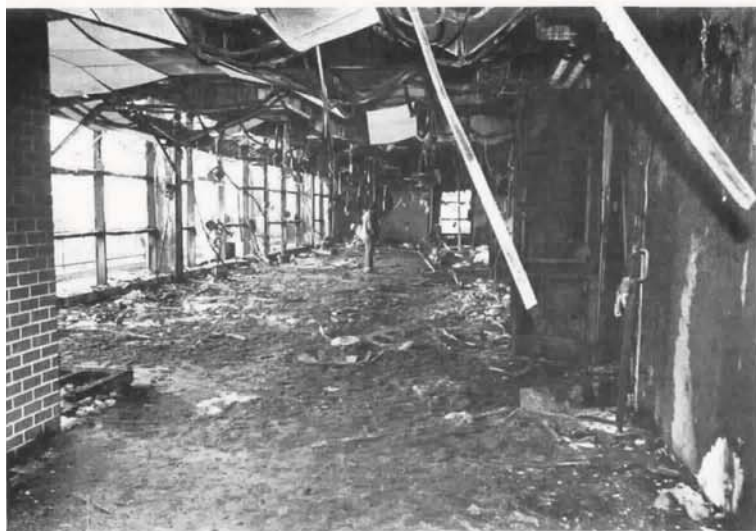
The Common, looking north toward the area of fire origin. Exit access door to the Wilson Room in the Grand Ballroom is at right. NFPA

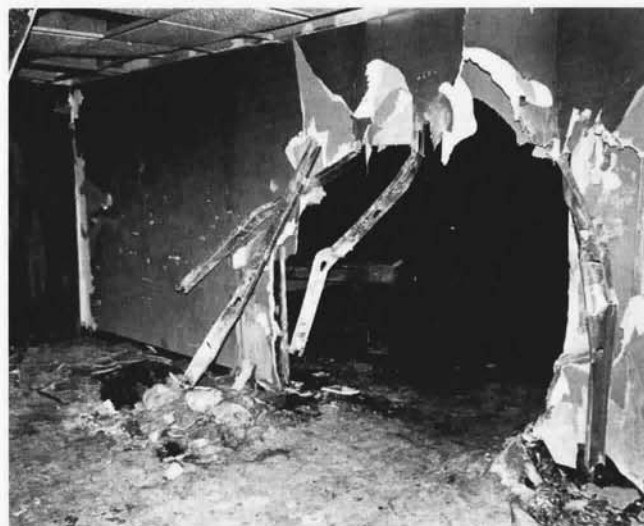
The wall between the Haight Room and the north exit corridor. Rescuers breached the wall in an effort to save the occupants. NFPA

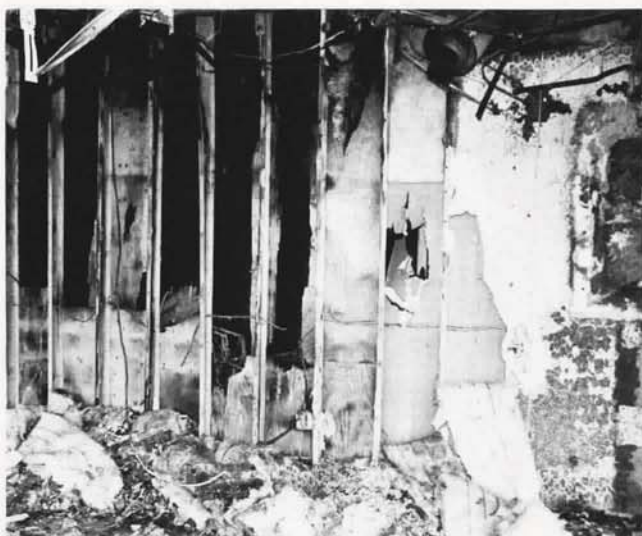
gypsum wallboard (non-type X) on either side of the studs. In most locations, one layer of 1/2-inch fire-retardant treated plywood was included between the steel studs and the gypsum wallboard. The resulting wall assemblies would not meet specifications for a 1-hour fire-rated wall assembly.

Corridor wall construction between Disbrow Room A and The Common, viewed from The Common. NFPA

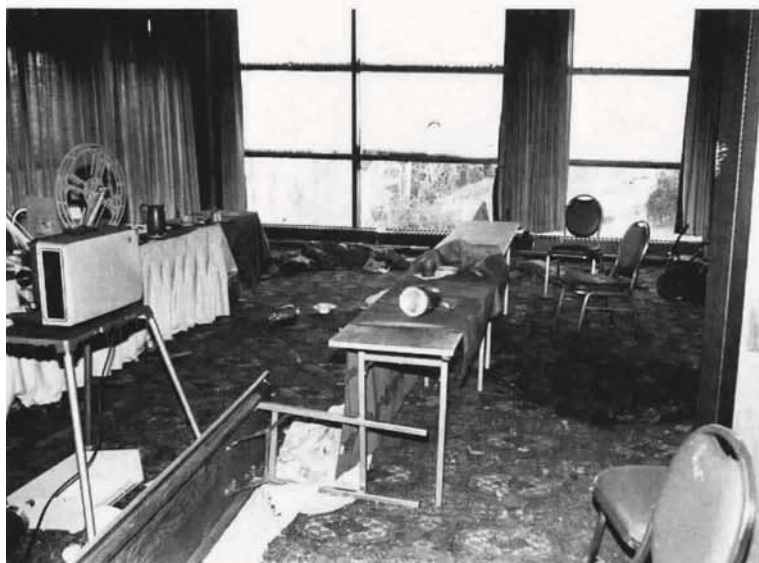
The Harrison Room, looking toward the north. Occupants of the room broke out the glass with a folding table and jumped to the ground 15 feet below. NFPA

With heavy black smoke filtering through cracks in both sets of doors, occupants were forced to break tempered glass window lites (panels). They made several attempts to break the glass, using chairs and a folding table. The occupants were finally able to break the glass on the north wall of the room by using a table as a battering ram. They jumped approximately 15 feet to rocky, uneven grade below, sustaining laceration and fracture injuries.

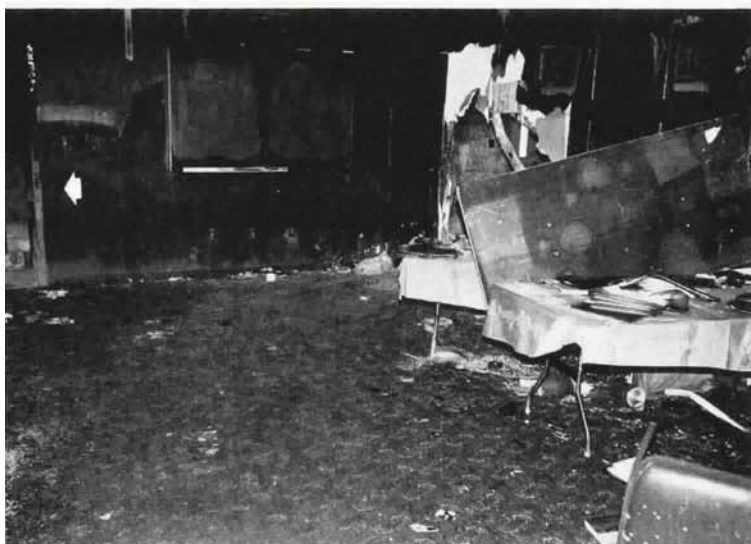
Eleven occupants of the Haight Room had remained in the room. Six of these occupants had apparently taken refuge from fire conditions that were entering the room

The Haight Room, where 12 executives were trapped when the one doorway into the corridor was blocked by fire conditions. Six of the occupants were found in the closet at left (see arrow). NFPA

by taking refuge in a storage closet. Five of the fatalities were found in the meeting-room area.

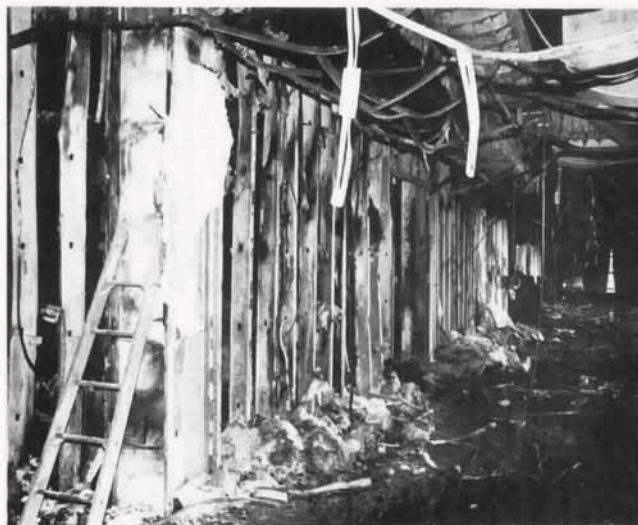
The Common, looking south from the area of fire origin. Exit access doorway from Disbrow Room A to The Common is in the center. NFPA

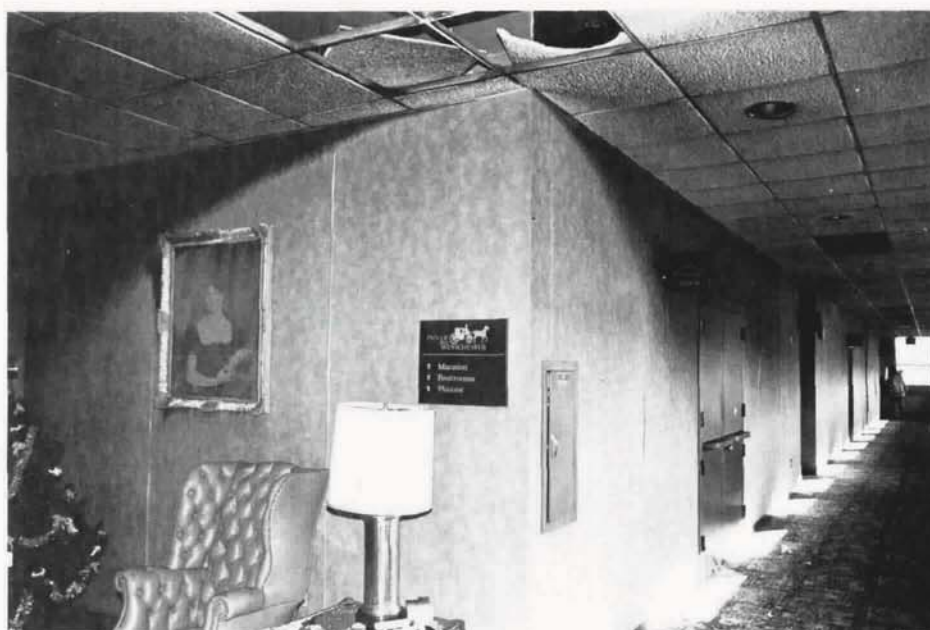
combustible furnishings, wall covering, carpeting, and decorations in The Common.<sup>8</sup> Although furnishings in The Common were "sparse," there was sufficient fuel loading to allow additional burning in that area. The extension of burning beyond the south end of The Common was limited by the domestic sprinkler protection.

Wall area at the south end of The Common at the intersection with the South Corridor seen at right. Pattern and effect of one of the four domestically fed sprinkler heads (top) is clearly shown. NFPA

If the conference facility building, including all places of assembly areas, had been protected with a complete automatic sprinkler system, the potential for injury or death of the occupants would most likely have been greatly reduced. Because of the critical location of the fire in the exit access corridors, smoke and heat conditions in those exit access areas would have existed even with complete sprinkler protection. However, once the system had activated, the ambient conditions of heat and smoke would most likely have remained at levels that would have enhanced the potential for survival of the meeting-room occupants.<sup>16</sup>
